Subj: USS MIAMI (SSN 755) FIRE PANEL RECOMMENDATIONS

**USS MIAMI (SSN 755)
Fire Review Panel**

1 October 2012

2. FIRE OVERVIEW

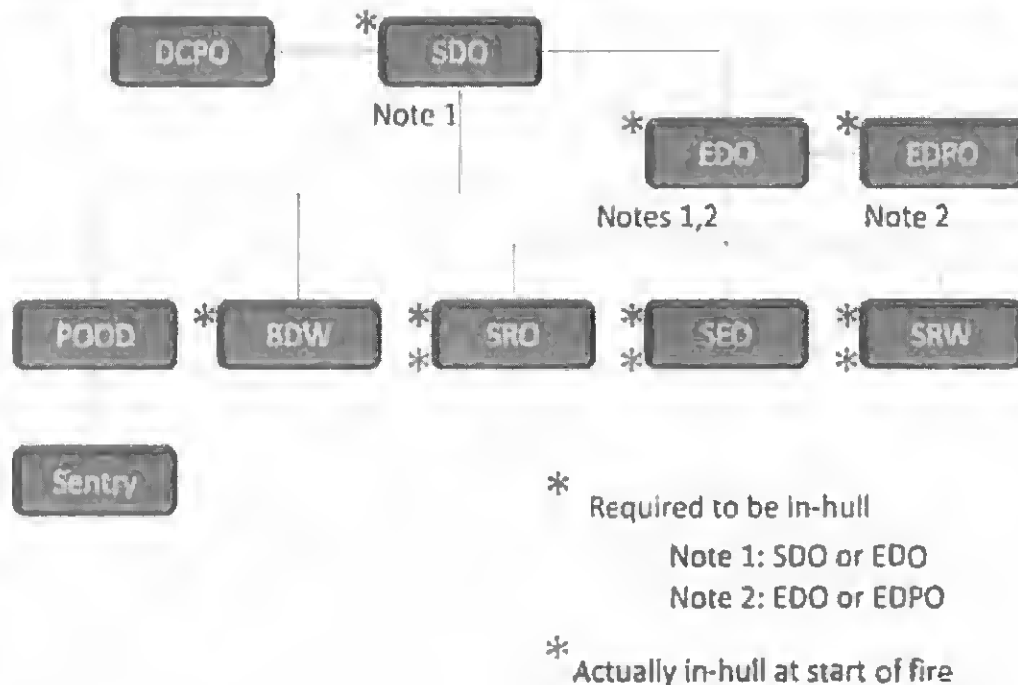
Figure 2: MIAMI In-port Watch Organization

3.1.4.1. Some allowable watchstander modifications result in reduced in-hull presence of roving watchstanders. TYCOM directives allow COs latitude on combining some non-propulsion plant watches. Some of these combinations result in roving watchstanders spending less time below decks. In an industrial environment, for periods with few or no crew members living aboard the ship, COs must carefully consider modifications that may compromise the effectiveness of the few roving watches available. Figure 2 illustrates MIAMI's in-port watch organization.

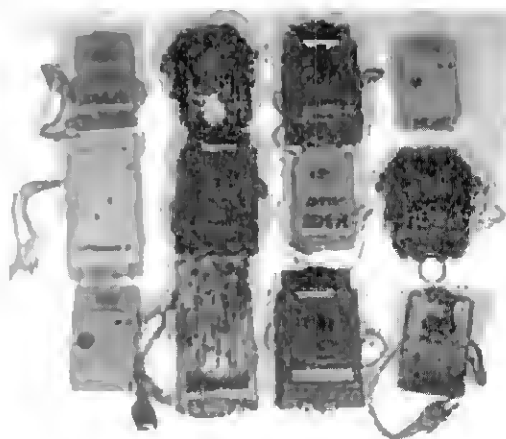
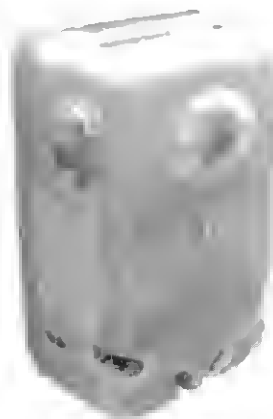
- (1) Ship's force firefighters are not provided with PASS devices.³⁵⁸
- (2) PASS are commercially available and provide an audible alarm and warning when fire responders become immobilized.^{359,360}

PASS devices:
